# Cheryl Lucas

## New Pots for Old

### *Grace Cochrane describes the reconstruction of chimneys in the aftermath of the New Zealand earthquakes*

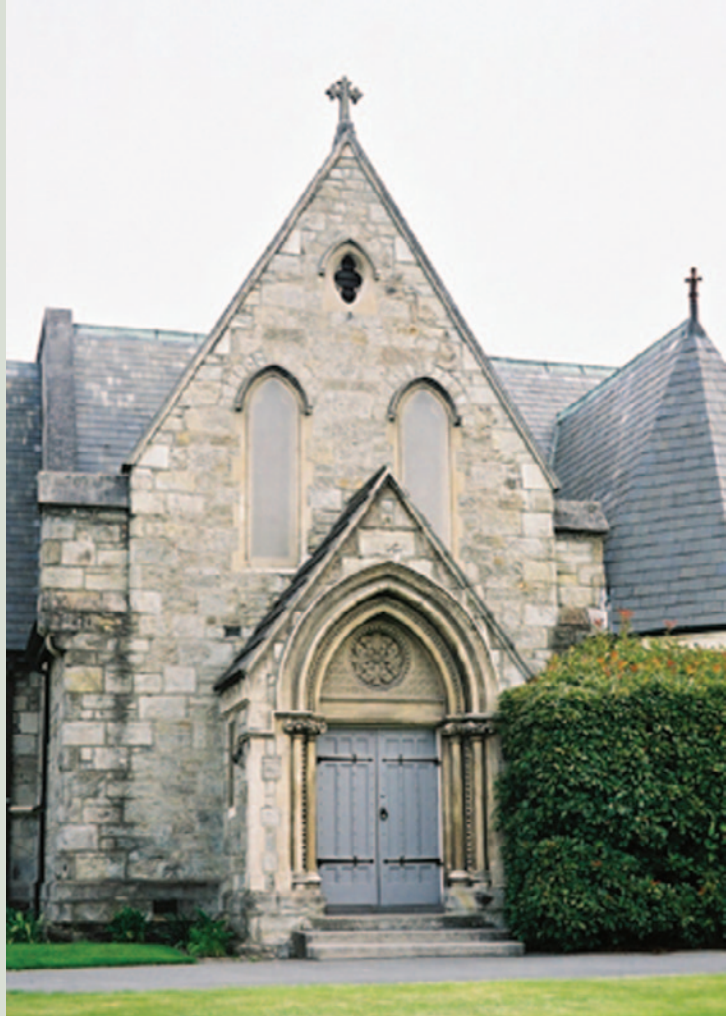
*Facing page: Chimney Pot made in stoneware for Rolleston House. 2012. 650 cm. Photo by Cheryl Lucas.  
Above: Cheryl Lucas made the finial on the right for this chapel at Christ's College. 2011. Photo by Cheryl Lucas.*

The next project was a 650cm-high chimney pot for Rolleston House, a timber building which had opened in 1919 as a hall of residence for what became Canterbury University and is now a youth hostel. Lucas worked from the architect’s drawing because despite archival research there was no evidence, in either fragments or photographs, of the shape of the original, and it had to fit the existing chimney stack. Again the piece was coil-thrown, in buff stoneware, then high-fired with the satin matt glaze, this time stained with an ochre colourant. Another chimney pot was then needed for the kitchen building for the present Canterbury University site in the suburb of Ilam. The exterior and interior dimensions for this short, wide pot were critical, because it had to fit an existing vent in the chimney. Again working from the architect’s drawings, Lucas threw this 500cm-wide piece in Abbot’s Brick Red terracotta clay, to be left unglazed. In each case the building sequence would originally have been in reverse, with the chimneys being made to accommodate the pots.

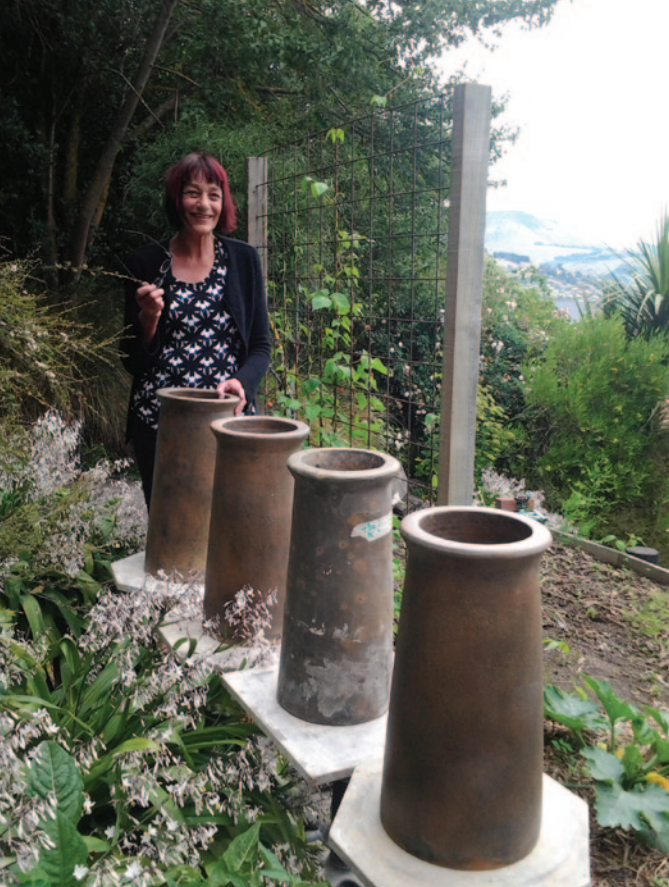
*Above: Cheryl Lucas with three replacement chimney pots made for a 1920s house, with original example second from the front.*

*2014. 520 cm. Photo by Peter Rough.*

In late 2014 Lucas completed three more chimney pots for another house in Cashmere, a project that came her way following a report on her work in the local paper. Measuring 590cm high when wet, she planned these "plain but lovely 1920s tapered pots" to shrink to 520cm when dry. And she is excited by a new project where one of the pots, made in the early 1880s, is signed "Austin & Kirk Ch Ch", a company that she can now find out more about in a recently published book entitled *All Fall Down: Christchurch's Lost Chimneys*. As she says, "It is absolutely fascinating, and it makes you realise how important it is to mark work."

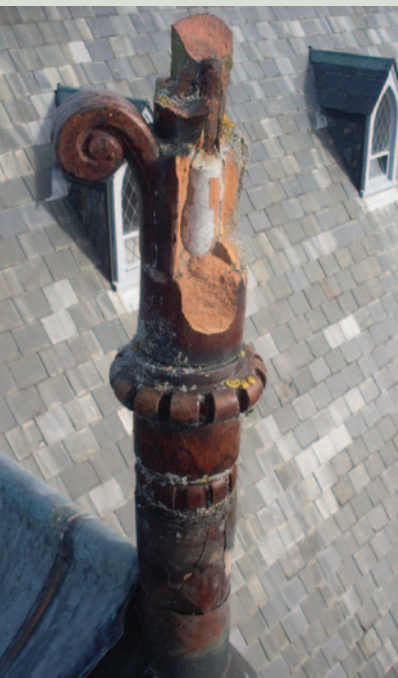
*Below left: Original broken finial on a chapel at Christ's College damaged in 2011.*

This project was followed in 2011 by a commission to remake a roof finial for a small chapel at Christ's College, which was founded in 1850 and whose complex includes the oldest school building still in use in New Zealand. The original finial had been made in three parts to fit over

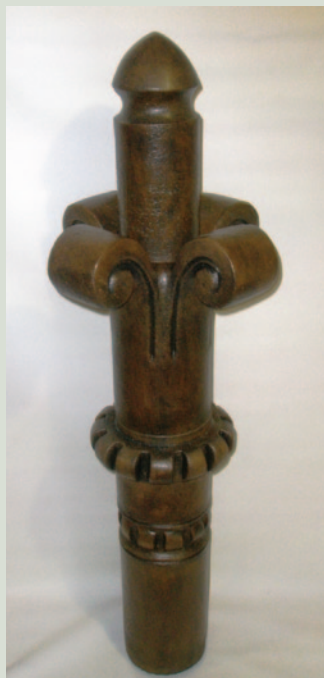
*Below right: Completed new finial made by Cheryl Lucas in three sections for a chapel at Christ's College. 2011. 1.75 m.*

a metal shaft, so Lucas faithfully made it again in sections, coil-throwing to build the forms in a buff-coloured Abbots stoneware clay that she used for sculptural work, testing and calculating shrinkage so that the finished piece would fit the shaft and its position on the roof. She acknowledges that her “biggest worry concerned the thickness of the scrolled part at the top of the finial, which might blow up in the kiln”, so dried it slowly over several months. The 1.2 metre-high piece was finished with a satin matt glaze which she used for her own work, with slips and oxides added to make a brown colour to match the original, which Lucas believes would have been soda-fired.

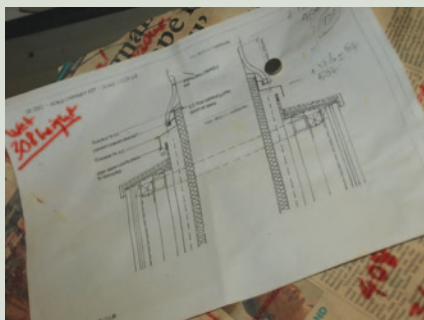
*Below: One of the Dyslexia House chimney stacks with tiles and chimney pots made by Cheryl Lucas on original bricks that she had refired. 2013.*

*Pots: 700 x 480 cm. Photo by Cheryl Lucas.*

Gothic-style Christchurch Arts Centre (formerly the site of Canterbury University College), it is in a busy area beside the tourist tram which runs between Cathedral Square (with its badly damaged cathedral) and the Canterbury Museum. The chimney stacks themselves were being rebuilt with 150 original bricks, but this time sliced in half lengthwise to make them lighter in weight. The stacks had been decorated with inserted patterned tiles, while each of the five original chimney pots, made at the Homebush Pottery, had four impressed patterns on their external surfaces. Lucas made 16 tiles; five chimney pots, four of them to be installed in pairs; and also refired the 150 cut, and now porous, bricks to ensure their strength.

The chimney-pots for Dyslexia House were massive. Originally made at the Homebush Pottery, at 700 x 480cm her versions were bigger than the originals because they were now to be used with a gas flue system and also had to have ‘weep-holes’ around each base. Working from a diagram of each location, issues included trying to make the original designs suit the larger scale and anticipating the consequent weight of the big pots on the chimney stacks. She coil-threw each one and, when they were leather hard, turned them over onto a mattress with the assistance

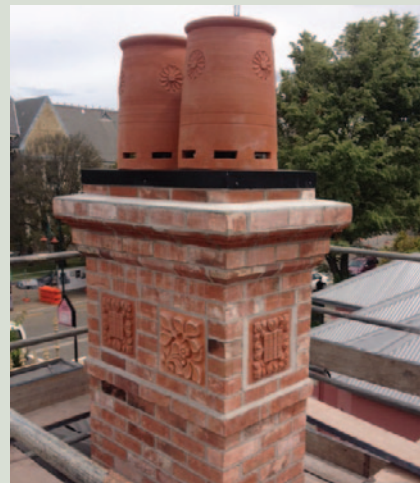
*Left: Example of an architect’s drawing showing proportions of the chimney stack for a chimney pot to go above the Canterbury University kitchen.*

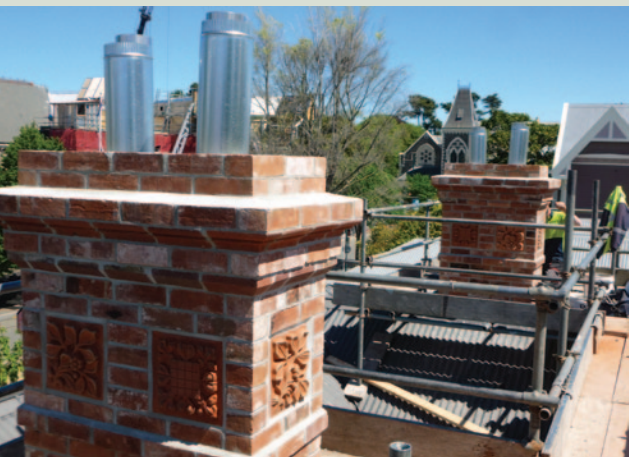
*Bottom left: Bricklayers from Stoneworks rebuilding the stacks before Lucas’ chimney pots were placed over the new flues. Photo by Cheryl Lucas.*

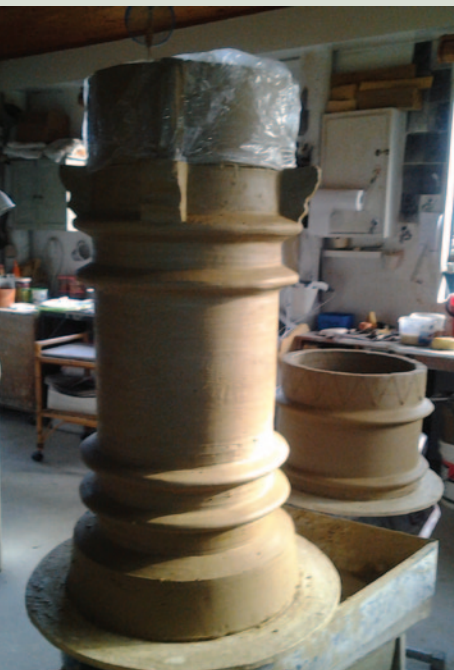
*Below left: Chimney pot components for Riccarton House awaiting final assembly before firing. 2014. 950 cm. Photo by Cheryl Lucas.*

An important separate commission came in 2014 from the family trust for the 160 year old Riccarton House. Located in what has been preserved as the Riccarton Bush in the centre of Christchurch, this was the home of the pioneering Deans family, who constructed it next to the 1844 Deans Cottage, identified as the oldest remaining colonial dwelling to be built on the Canterbury Plains, following initial settlement at the port of Lyttelton. This important building had 12 chimney pots, in pairs and a group of four, but one of these metre-high pots had broken and, as it was part of a pair, it was again critical to test shrinkage and glazes to get the dimensions, shape and colour correct. This pot was not only large, but heavy, as the crown had been made separately to slide down over the column and rest on lugs below the top. "It was a critical process to lift the crown and combine them at the same stage of wetness so they would adhere and dry evenly," Lucas explains.

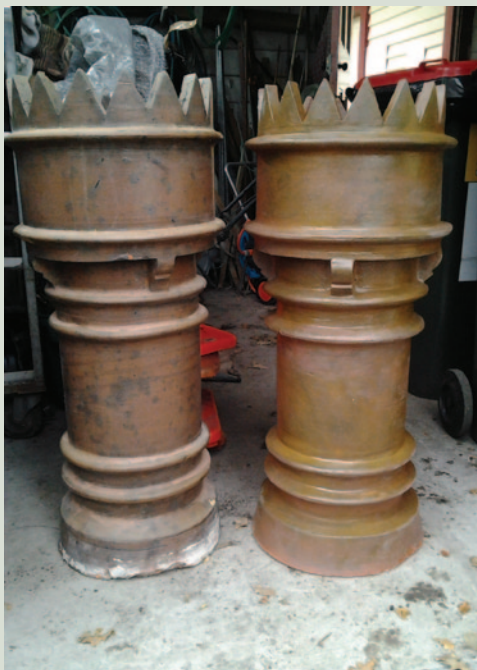
*Below right: On the left, one of the 11 original chimney pots from Riccarton House, next to the replacement for the damaged 12th pot. 2014. 950 cm.*

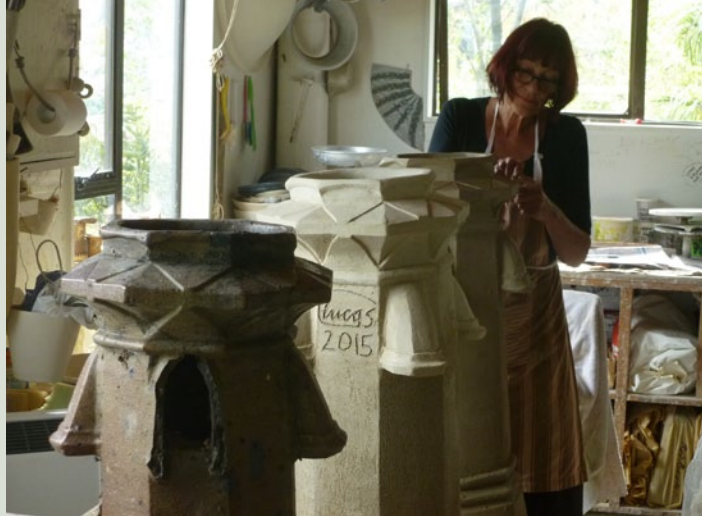
*Top: Cheryl Lucas making two replacements for a broken Austin & Kirk pot of 1879/1880 for a triple brick house built in 1885. 2015.*

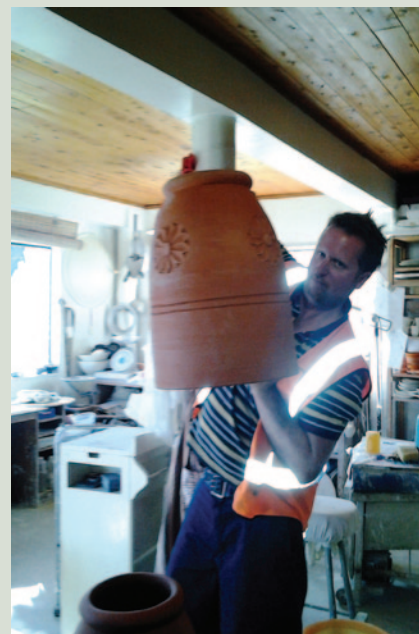
*Above: Ben West with one of the chimney pots for the School House, Christ's College. 2013. 520 cm.*

Seal of Japan. Lucas carved these separately, developing a system using plastic lids and incising tools to locate and mark each circle and central dot, before working on additional incisions for the radiating petals. Later, back again at Christ's College, three similar chimney pots were needed at the residential School House. These were made in the same style and decoration as those on Dyslexia house, but in the original smaller size.
